## A summary of the work carried out in the Month of March 2026

## Cyclops restoration programme March 2026

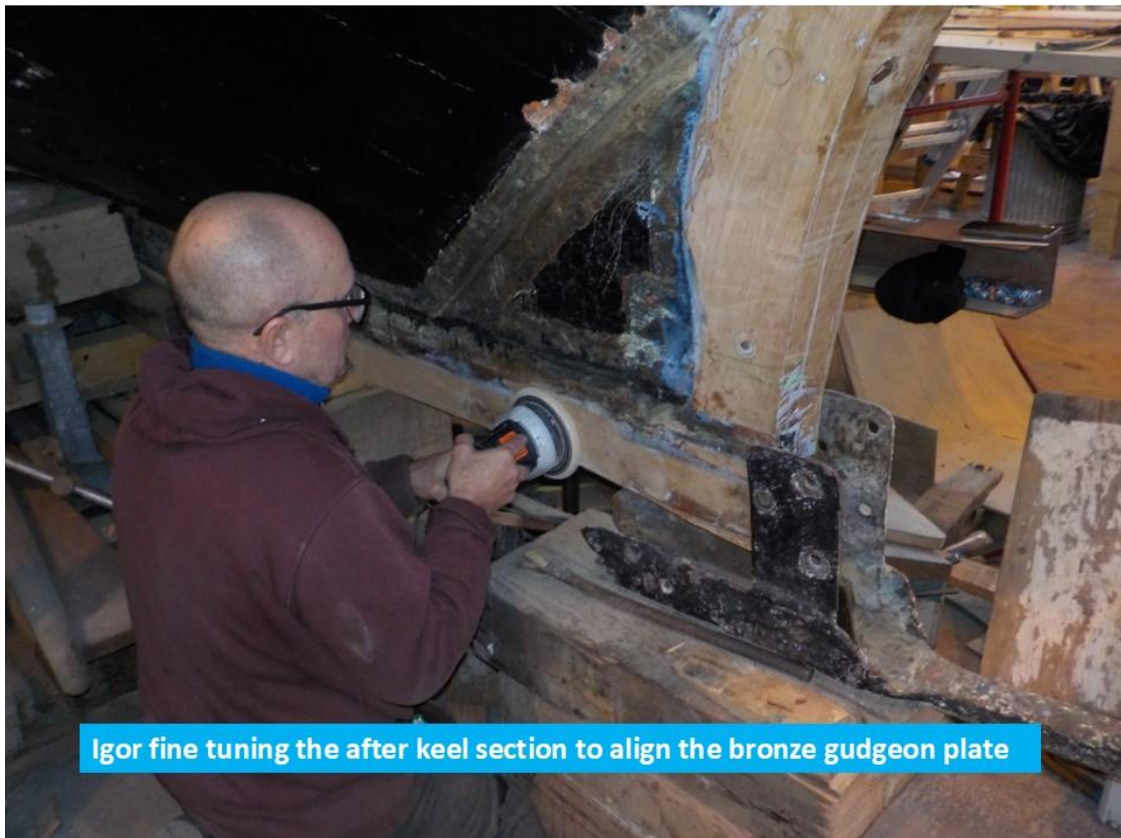
Igor fine tuning the after keel section to align the bronze gudgeon plate

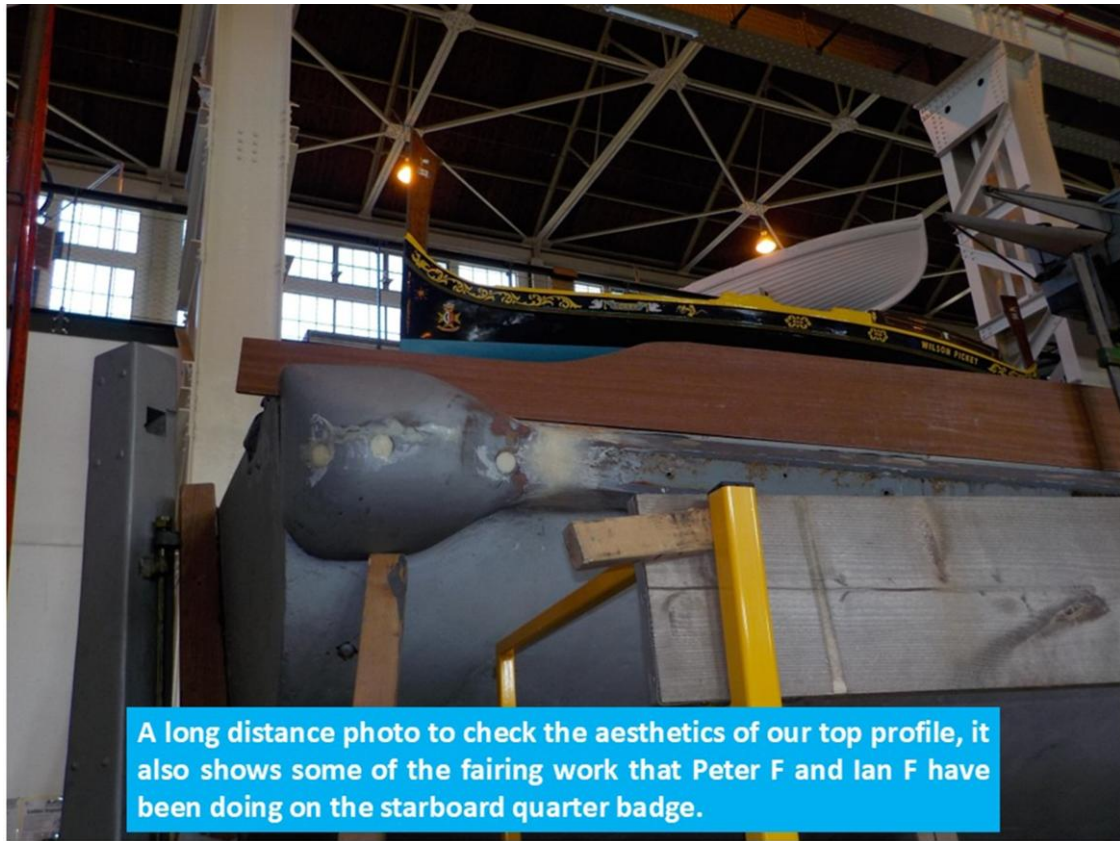
A long distance photo to check the aesthetics of our top profile, it also shows some of the fairing work that Peter F and Ian F have been doing on the starboard quarter badge.

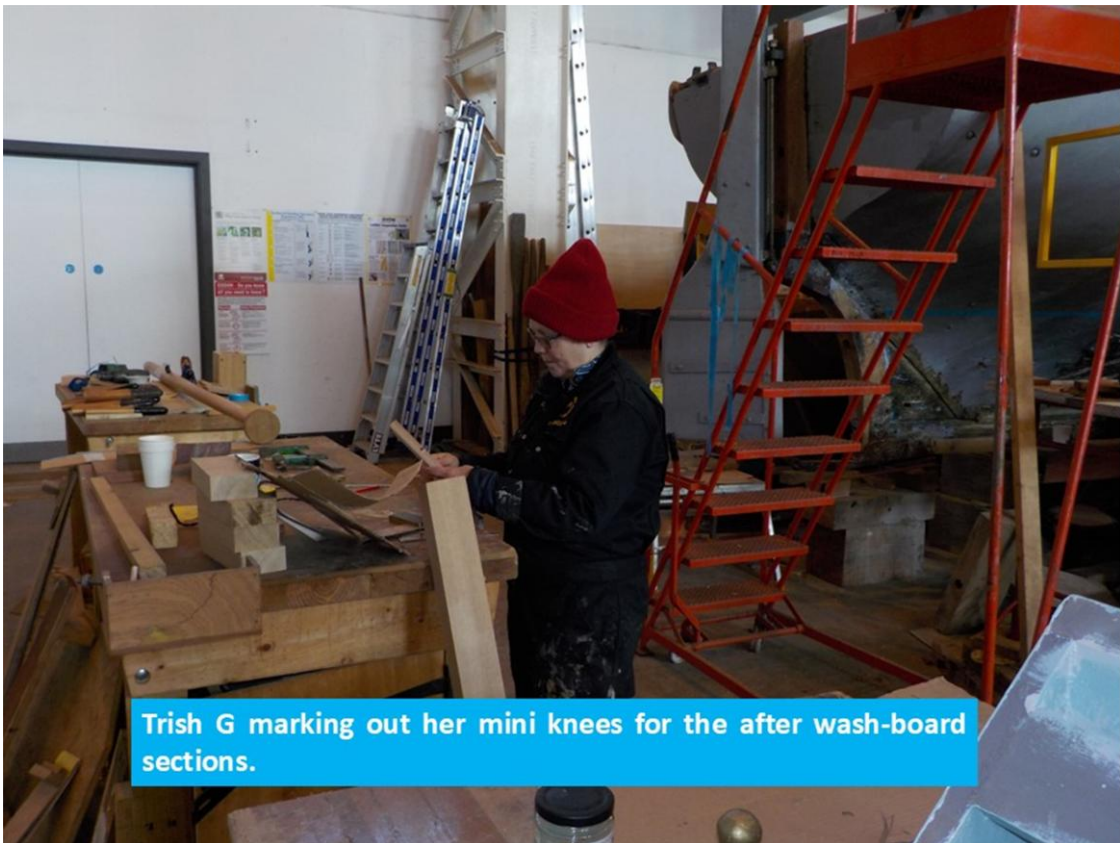
Trish G marking out her mini knees for the after wash-board sections.

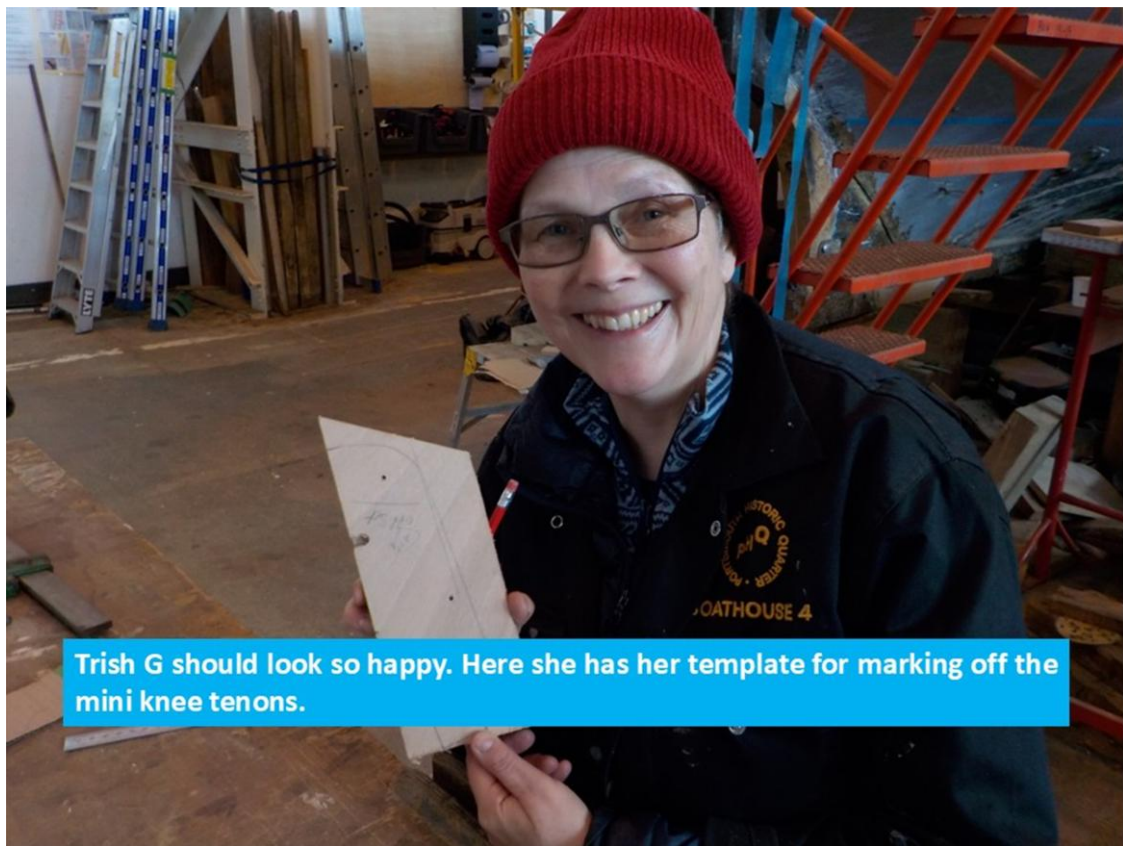
Trish G should look so happy. Here she has her template for marking off the mini knee tenons.

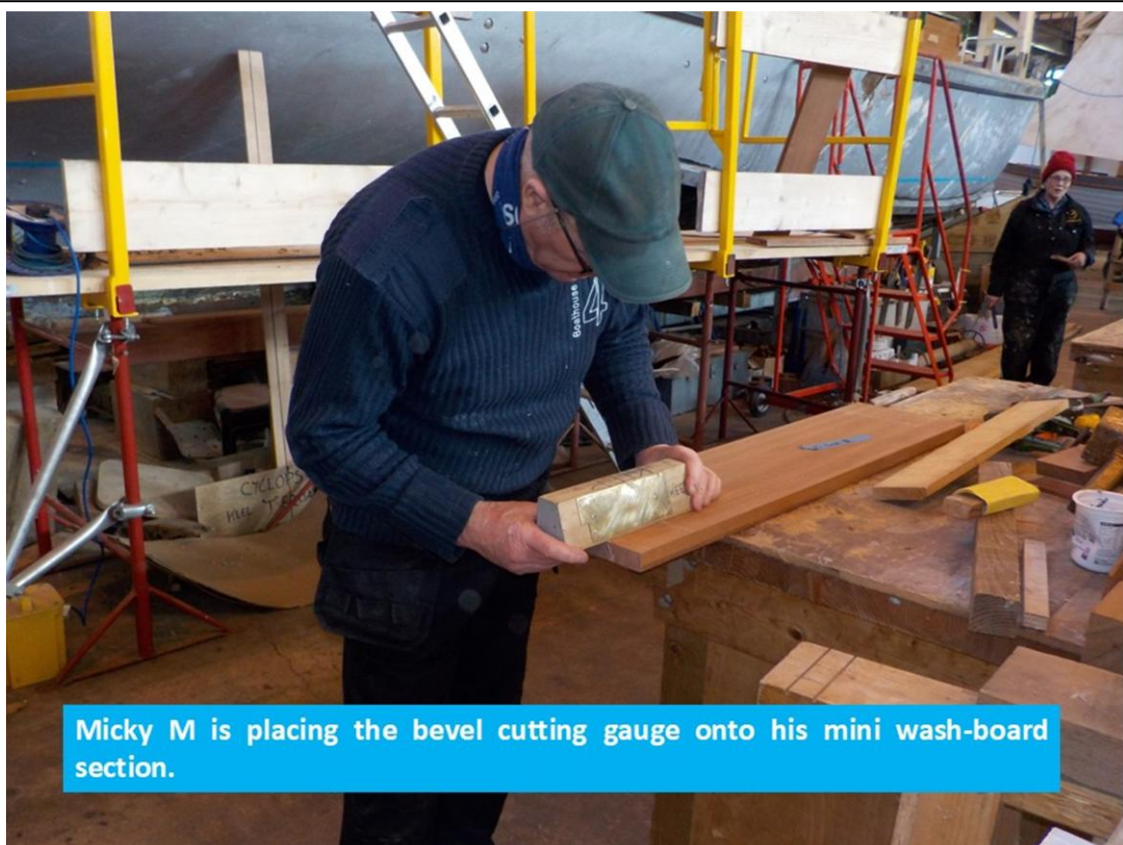
Micky M is placing the bevel cutting gauge onto his mini wash-board section.

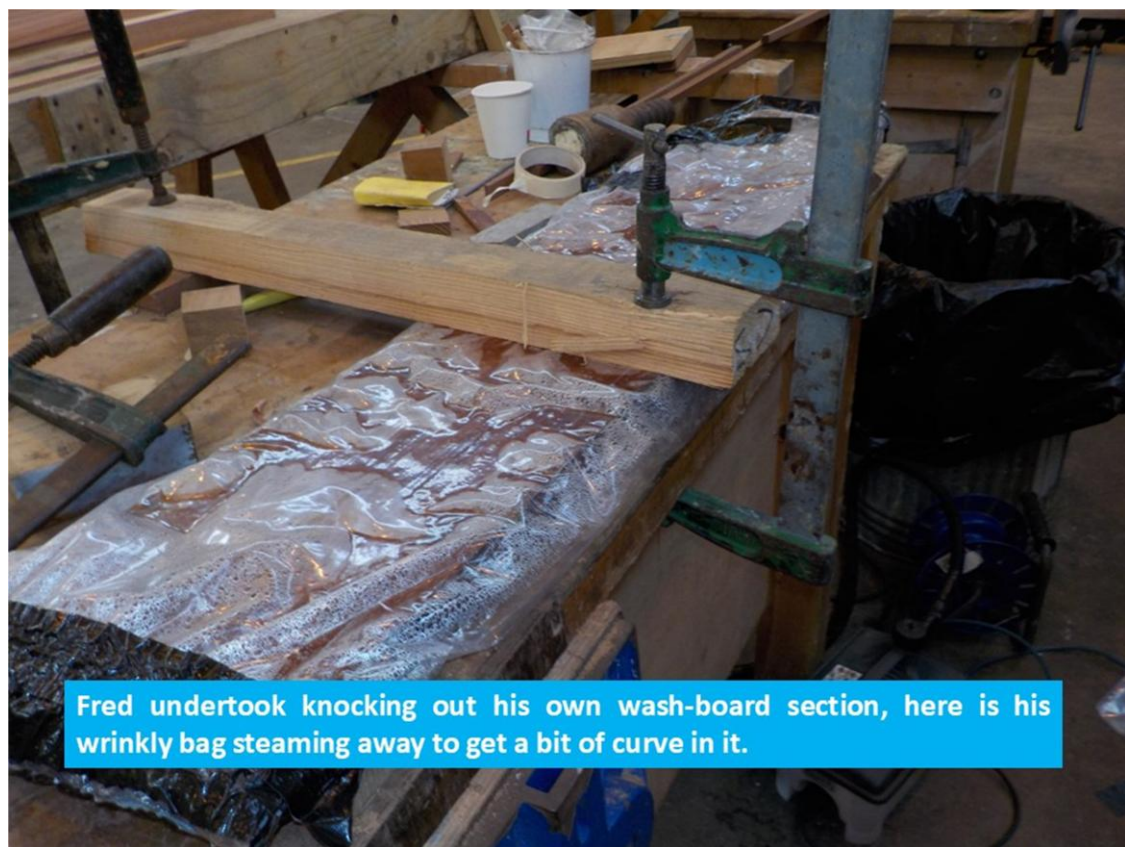
Fred undertook knocking out his own wash-board section, here is his wrinkly bag steaming away to get a bit of curve in it.

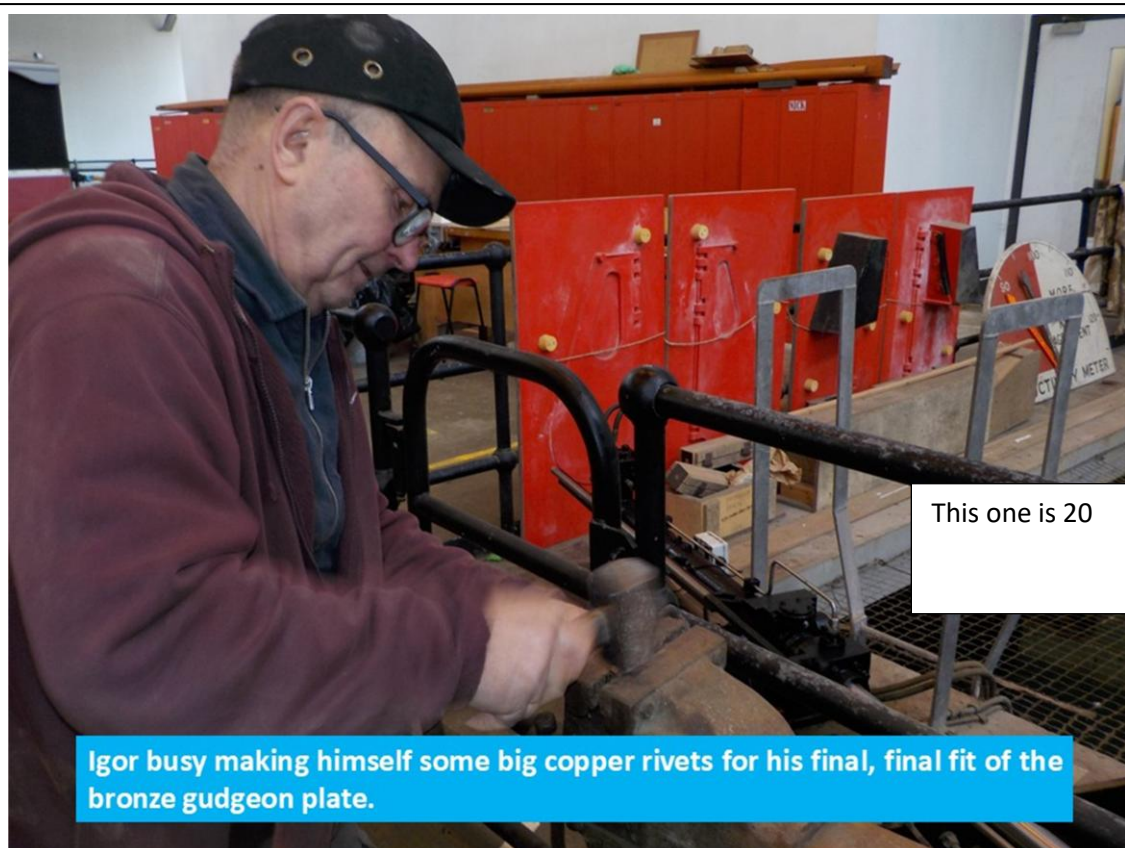
This one is 20

Igor busy making himself some big copper rivets for his final, final fit of the bronze gudgeon plate.

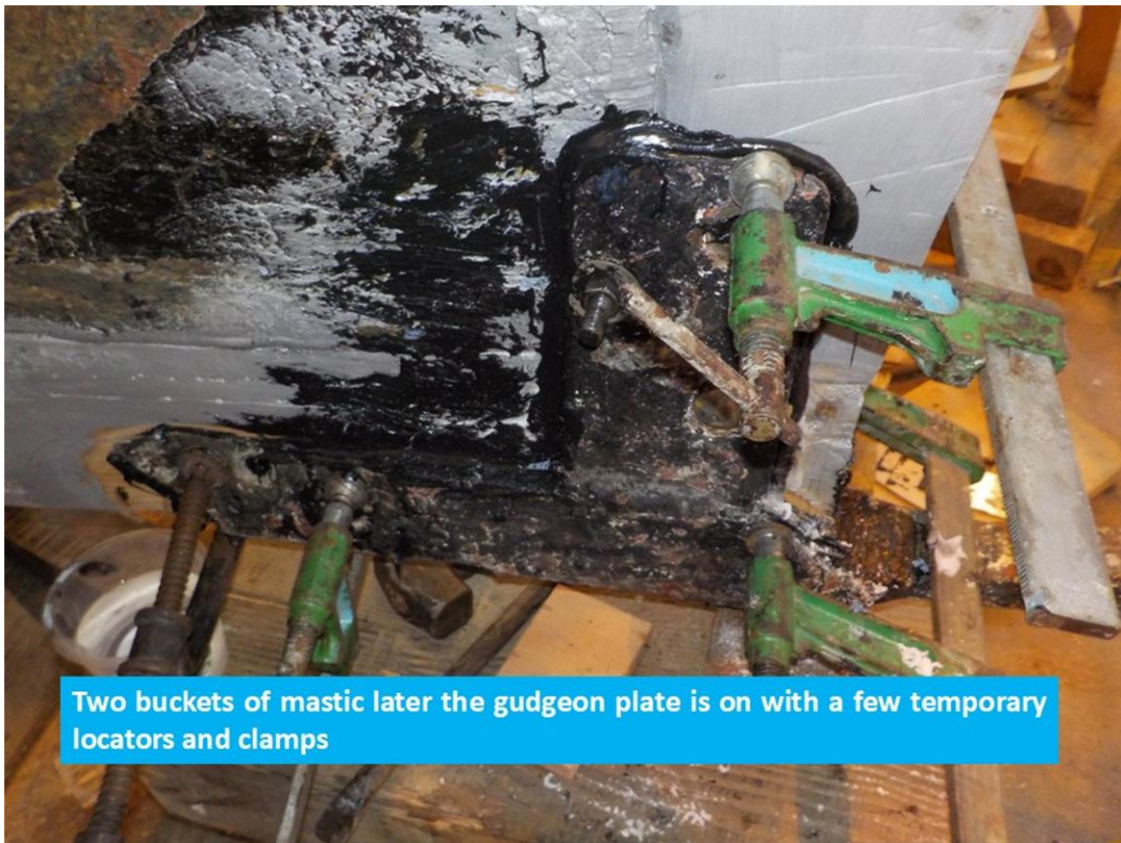
Two buckets of mastic later the gudgeon plate is on with a few temporary locators and clamps

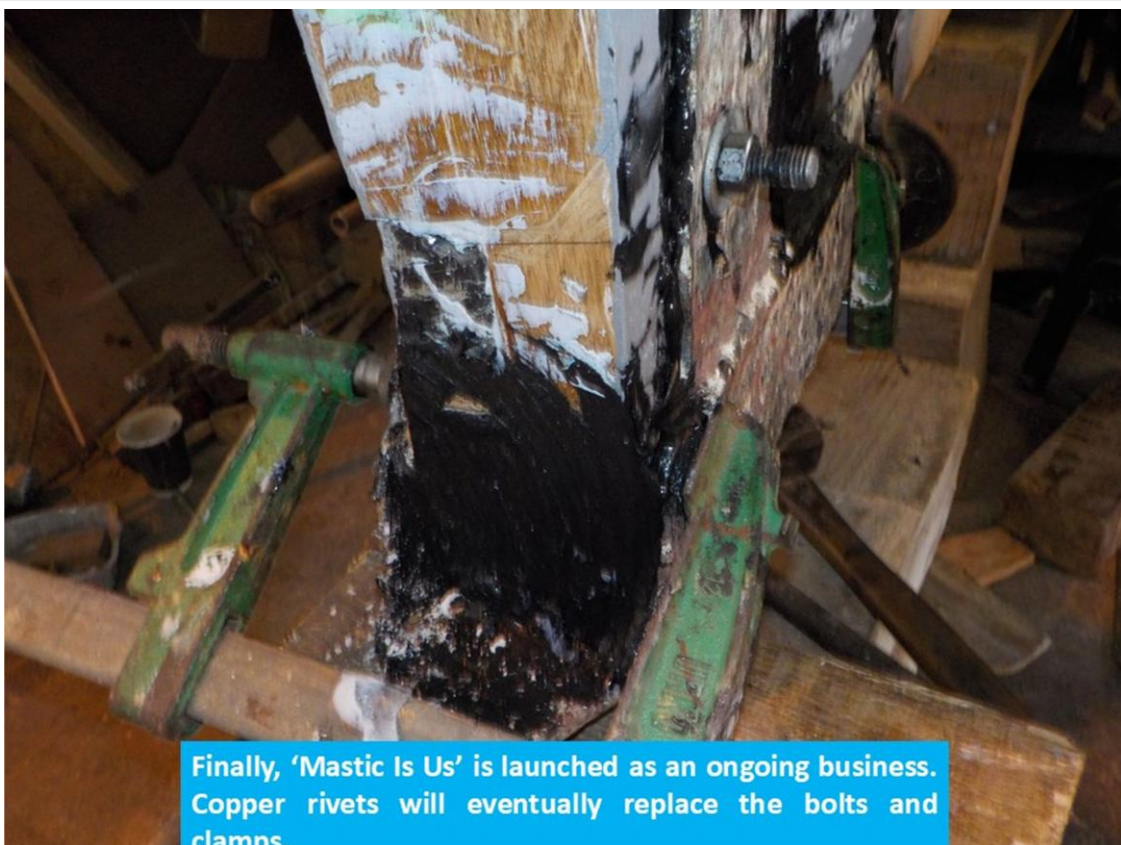
Finally, 'Mastic Is Us' is launched as an ongoing business. Copper rivets will eventually replace the bolts and clamps.

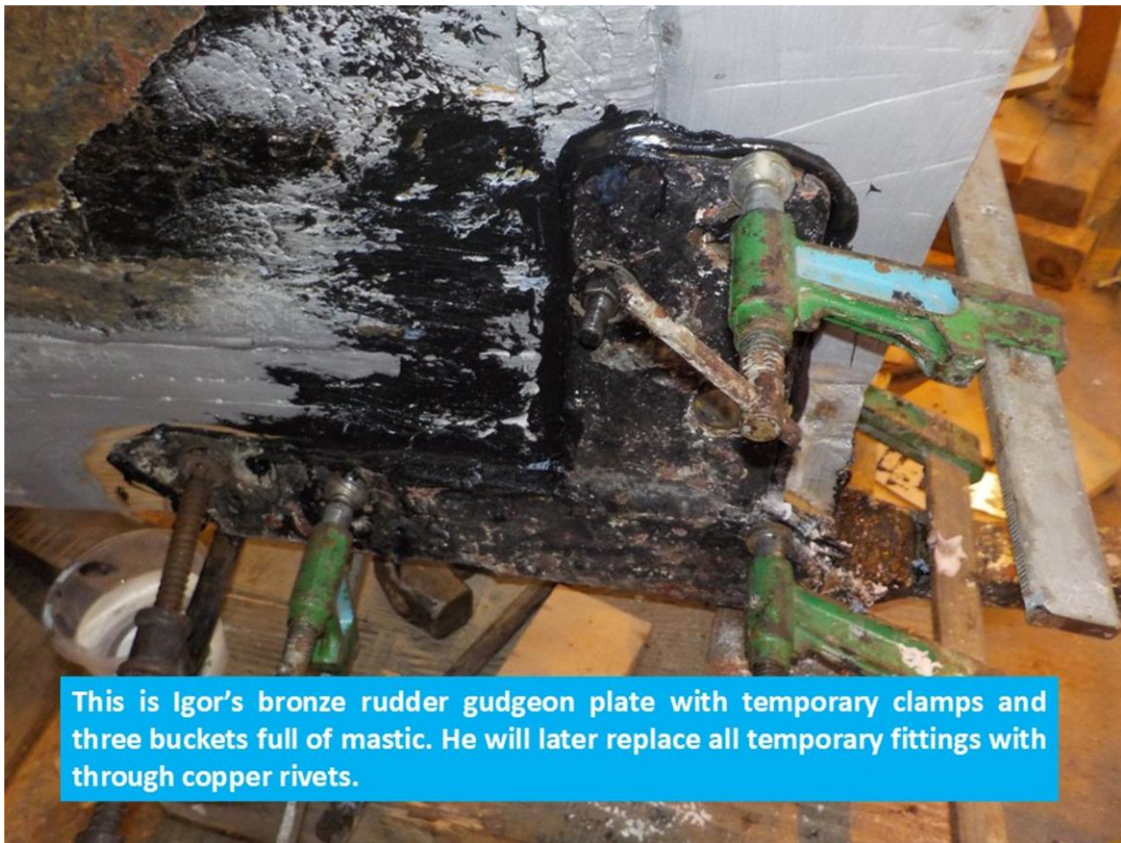
This is Igor's bronze rudder gudgeon plate with temporary clamps and three buckets full of mastic. He will later replace all temporary fittings with through copper rivets.

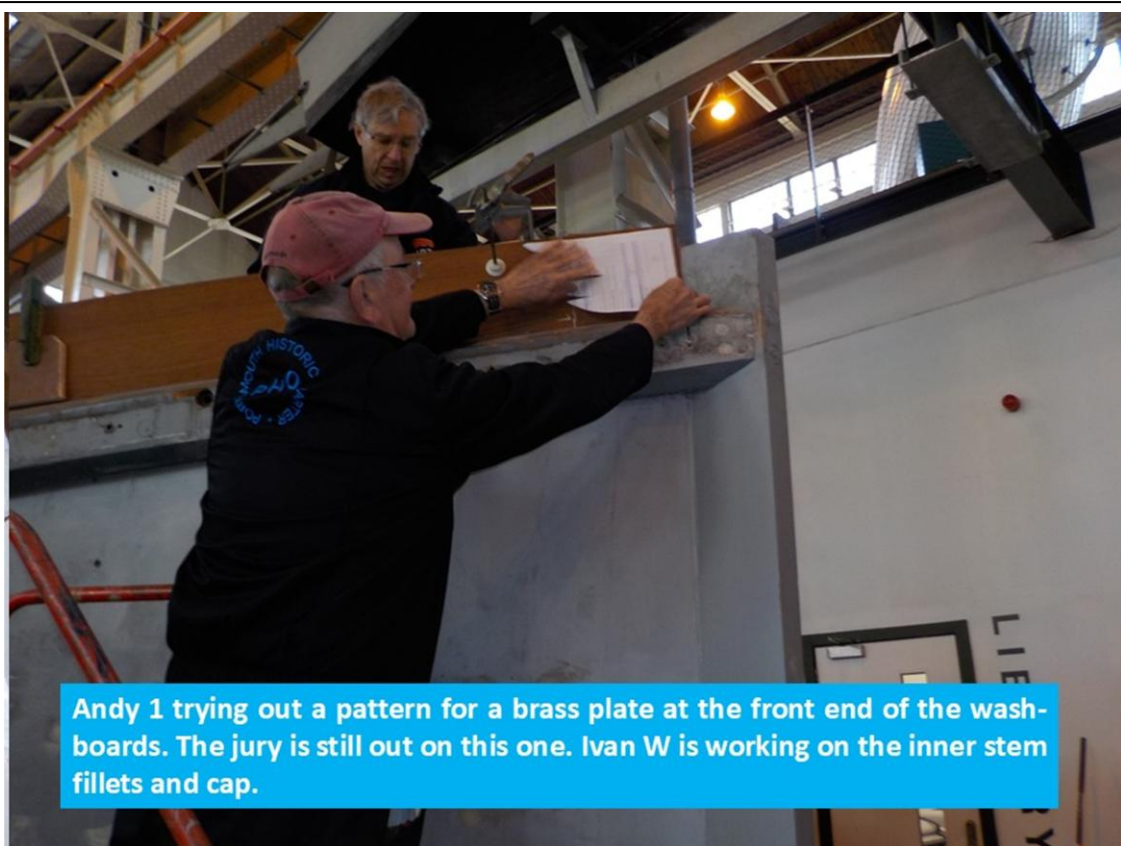
Andy 1 trying out a pattern for a brass plate at the front end of the washboards. The jury is still out on this one. Ivan W is working on the inner stem fillets and cap.

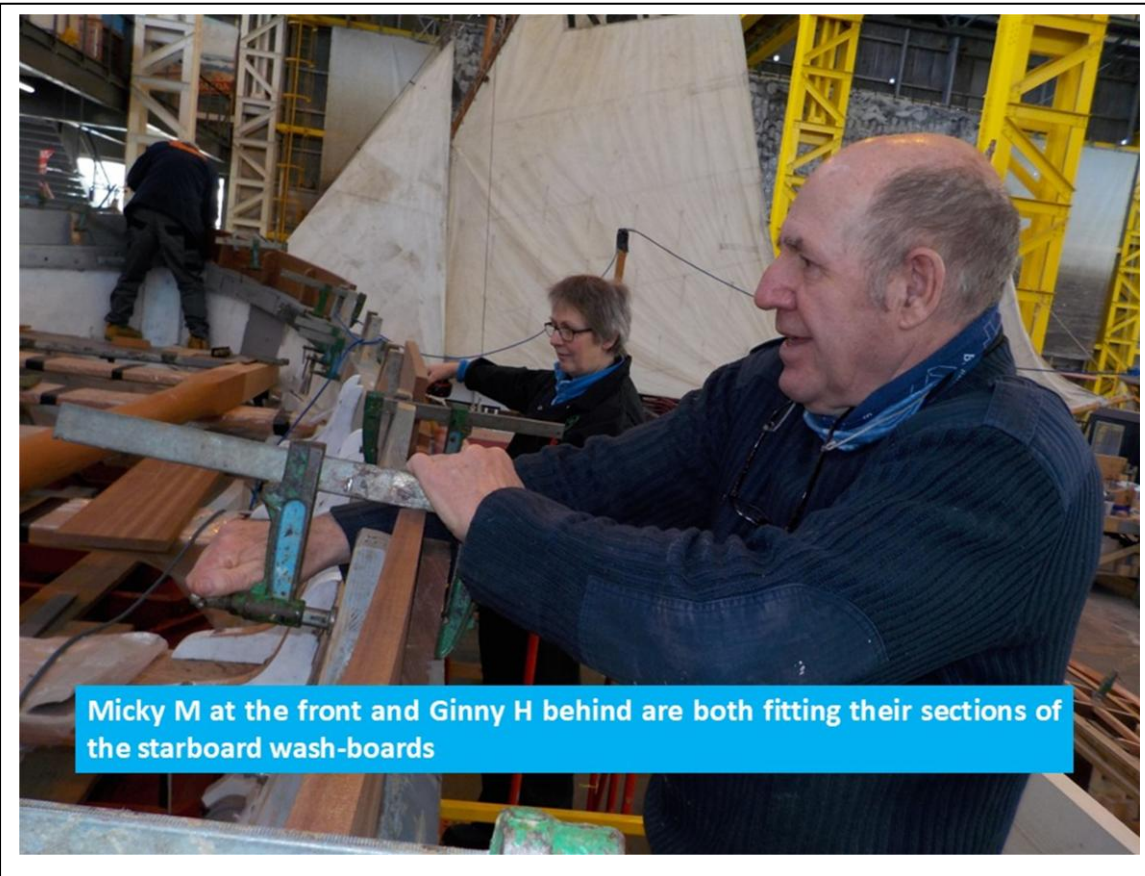
Micky M at the front and Ginny H behind are both fitting their sections of the starboard wash-boards

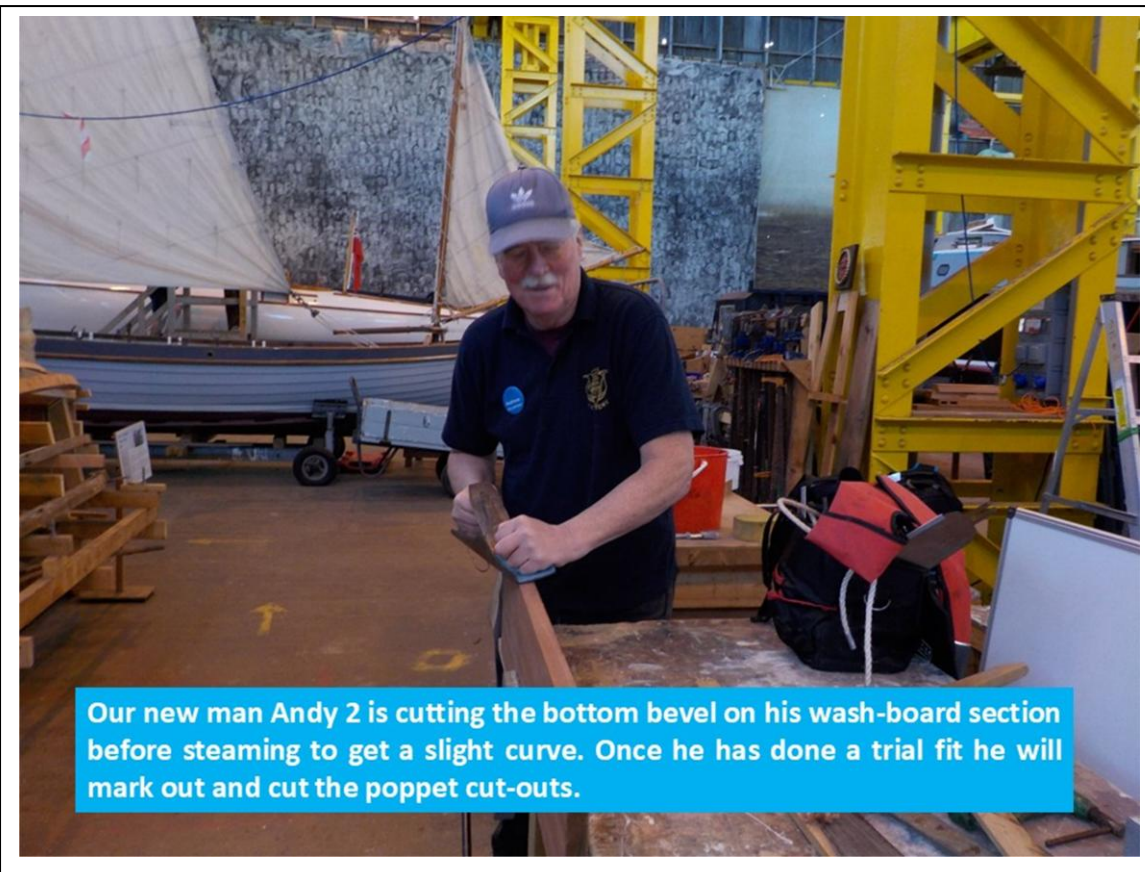
Our new man Andy 2 is cutting the bottom bevel on his wash-board section before steaming to get a slight curve. Once he has done a trial fit he will mark out and cut the poppet cut-outs.

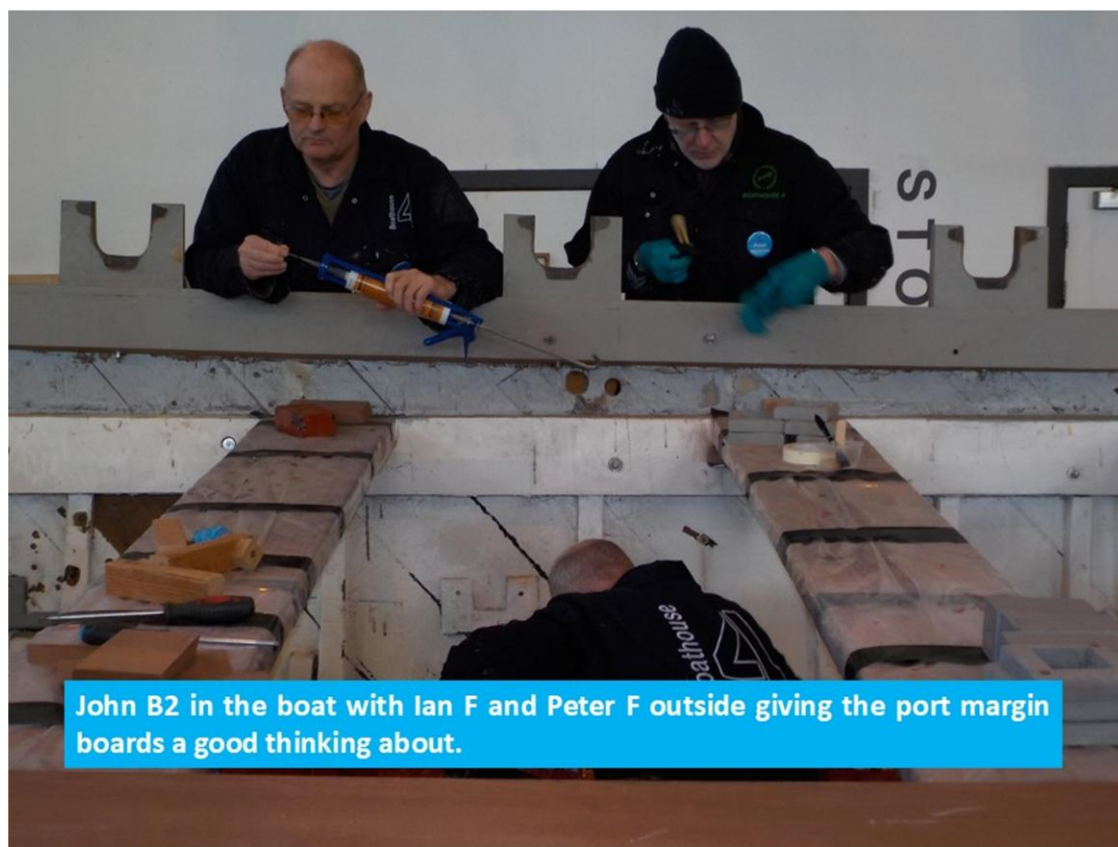
John B2 in the boat with Ian F and Peter F outside giving the port margin boards a good thinking about.

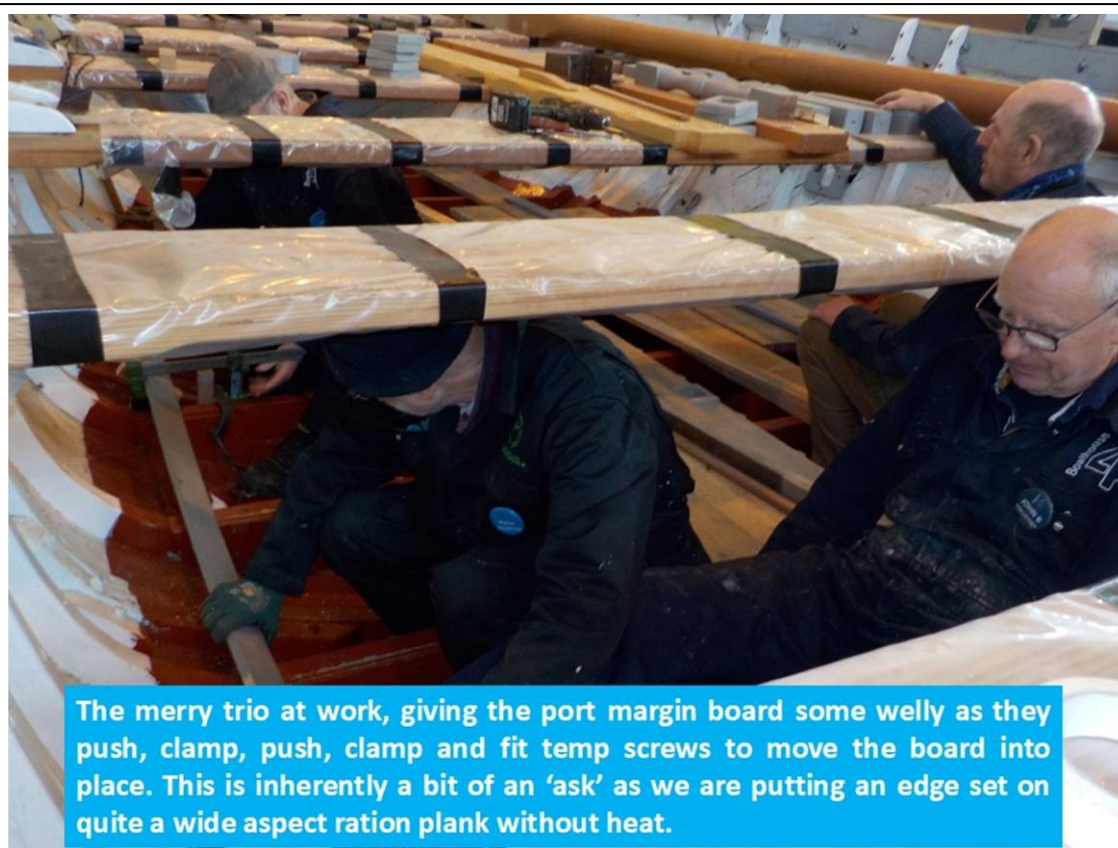
The merry trio at work, giving the port margin board some welly as they push, clamp, push, clamp and fit temp screws to move the board into place. This is inherently a bit of an 'ask' as we are putting an edge set on quite a wide aspect ration plank without heat.

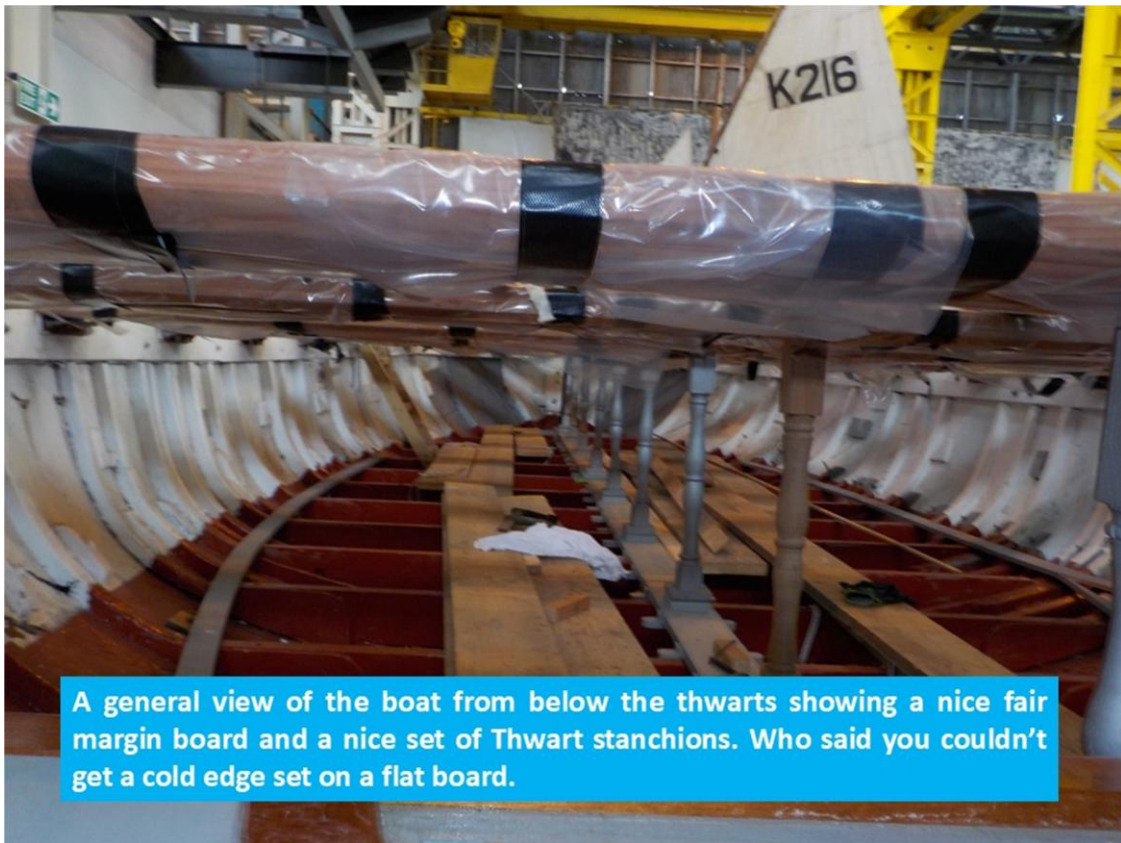
A general view of the boat from below the thwarts showing a nice fair margin board and a nice set of Thwart stanchions. Who said you couldn't get a cold edge set on a flat board.

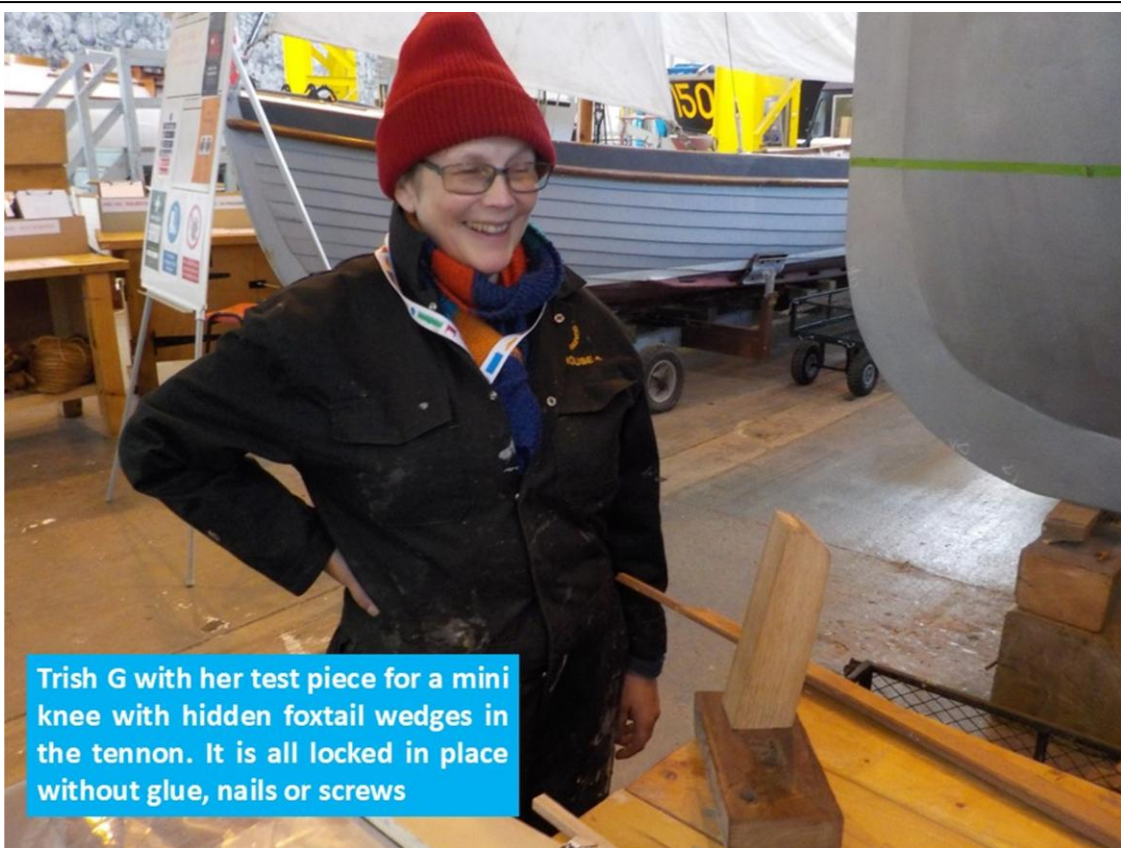
Trish G with her test piece for a mini knee with hidden foxtail wedges in the tennon. It is all locked in place without glue, nails or screws

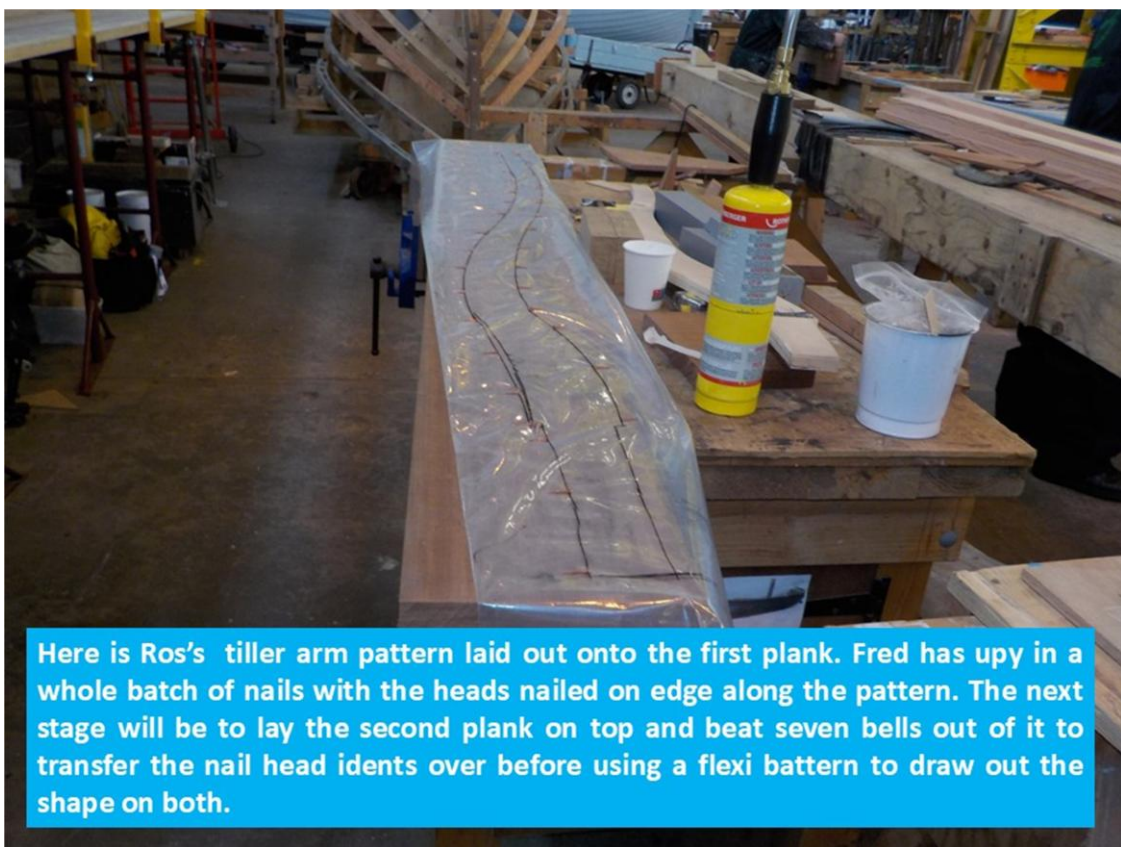
Here is Ros's tiller arm pattern laid out onto the first plank. Fred has up in a whole batch of nails with the heads nailed on edge along the pattern. The next stage will be to lay the second plank on top and beat seven bells out of it to transfer the nail head idents over before using a flexi battern to draw out the shape on both.

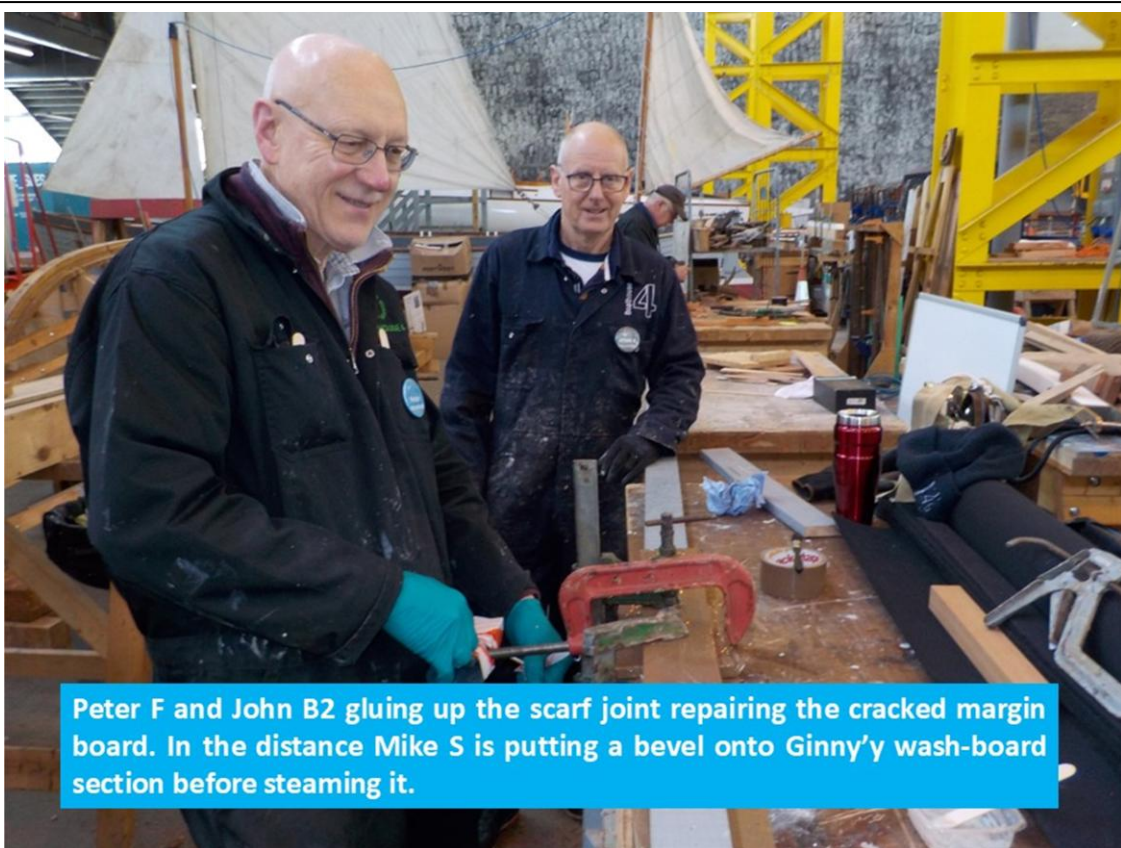
Peter F and John B2 gluing up the scarf joint repairing the cracked margin board. In the distance Mike S is putting a bevel onto Ginny'y wash-board section before steaming it.

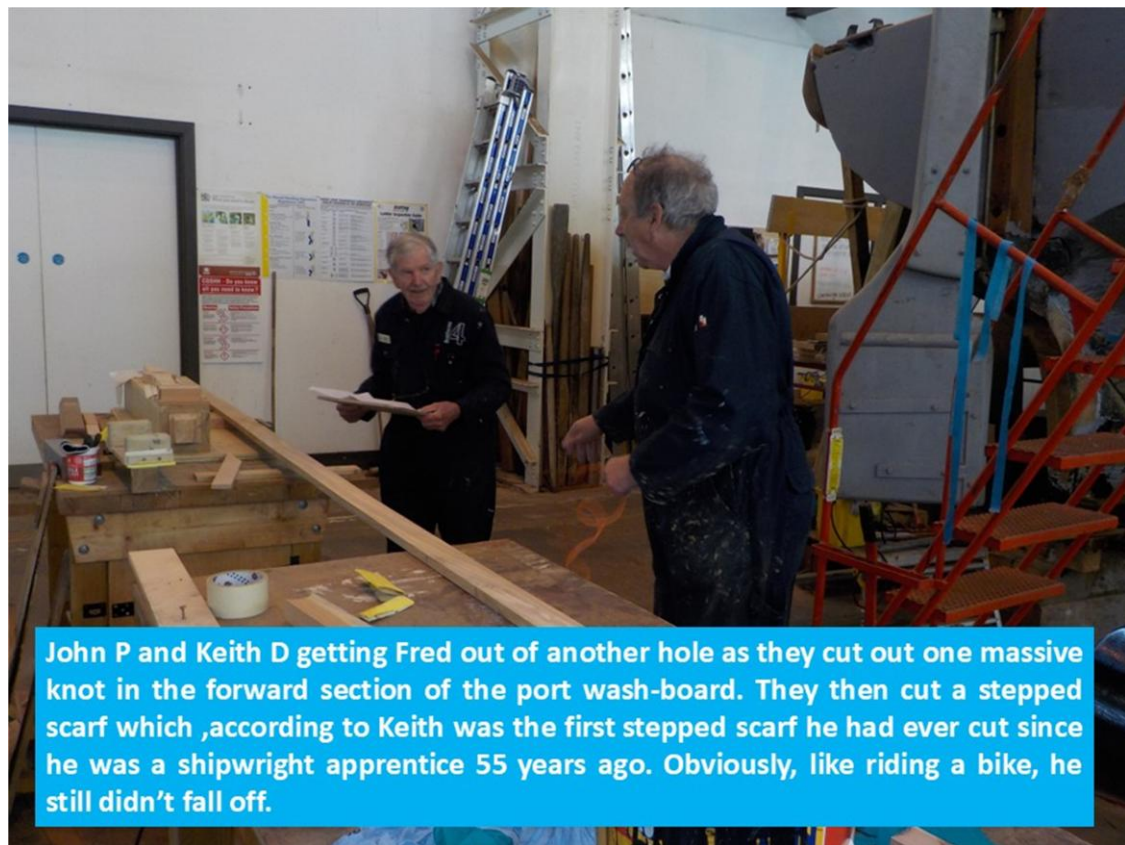
John P and Keith D getting Fred out of another hole as they cut out one massive knot in the forward section of the port wash-board. They then cut a stepped scarf which ,according to Keith was the first stepped scarf he had ever cut since he was a shipwright apprentice 55 years ago. Obviously, like riding a bike, he still didn't fall off.

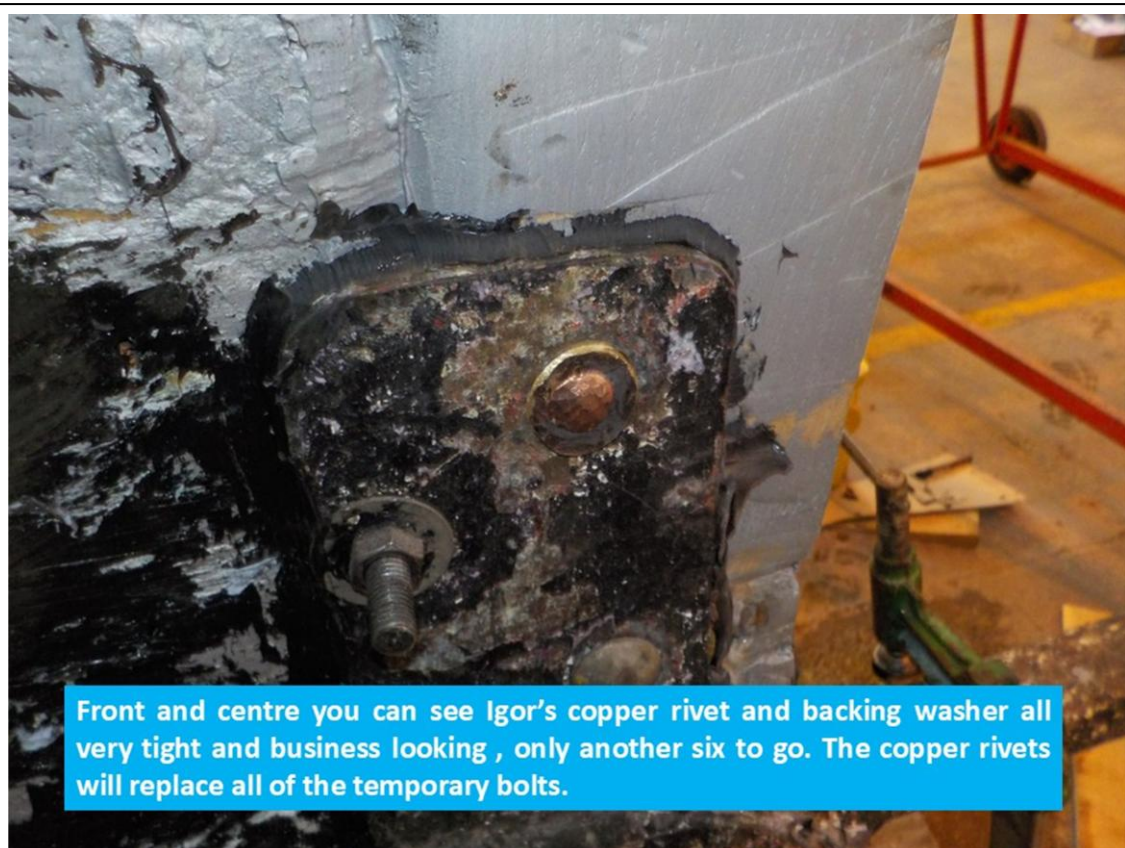
Front and centre you can see Igor's copper rivet and backing washer all very tight and business looking , only another six to go. The copper rivets will replace all of the temporary bolts.
