### A summary of the work carried out in the Month of April 2026

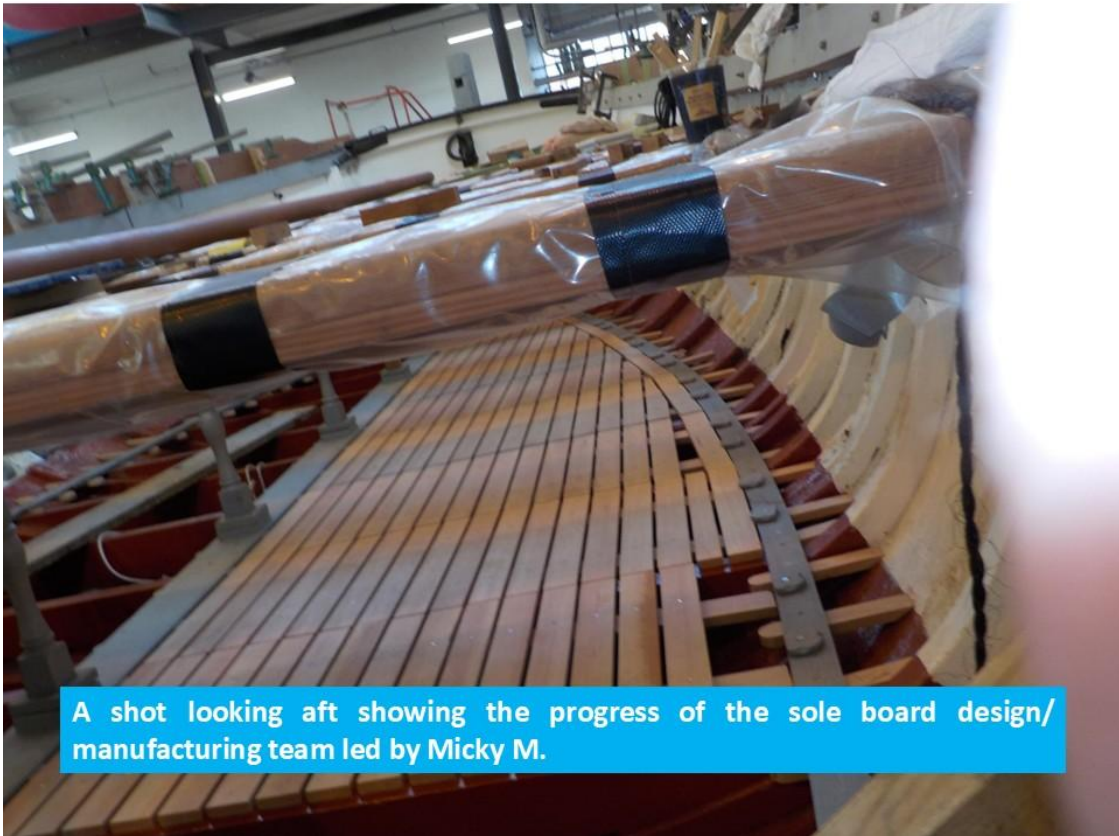
A shot looking aft showing the progress of the sole board design/manufacturing team led by Micky M.

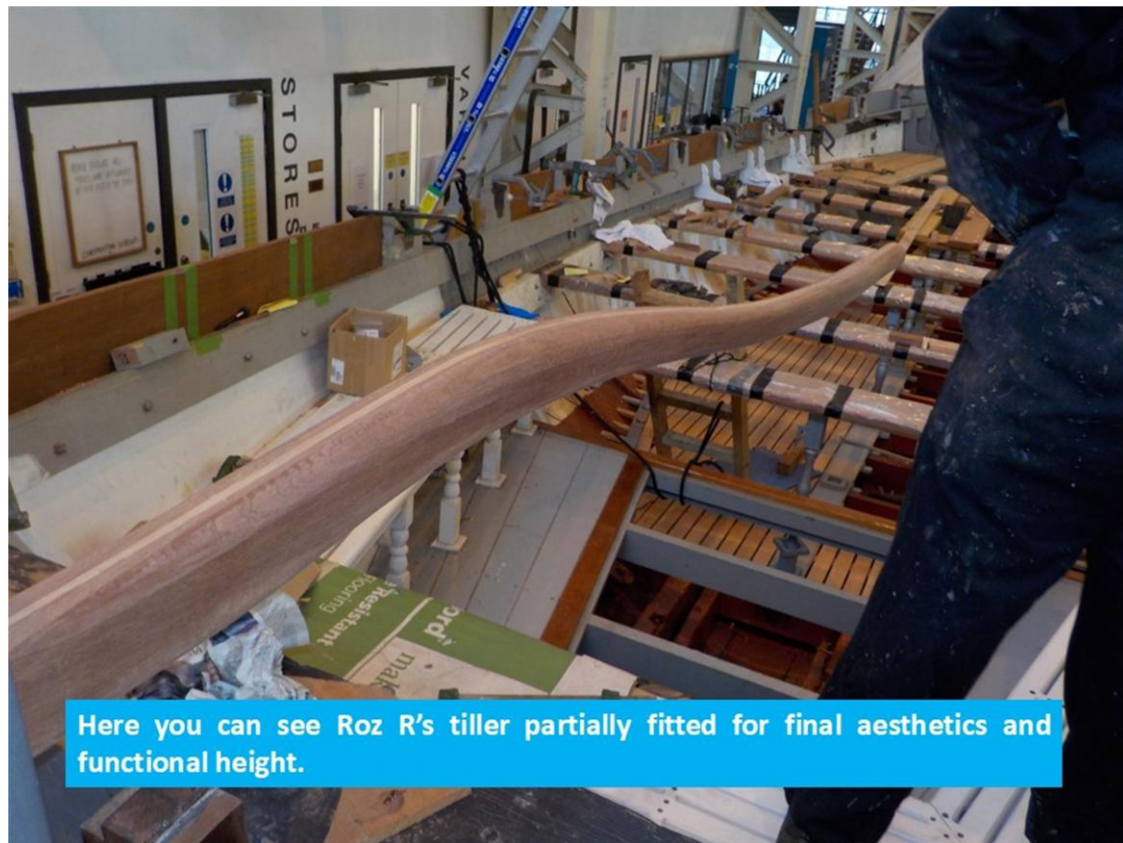
Here you can see Roz R's tiller partially fitted for final aesthetics and functional height.

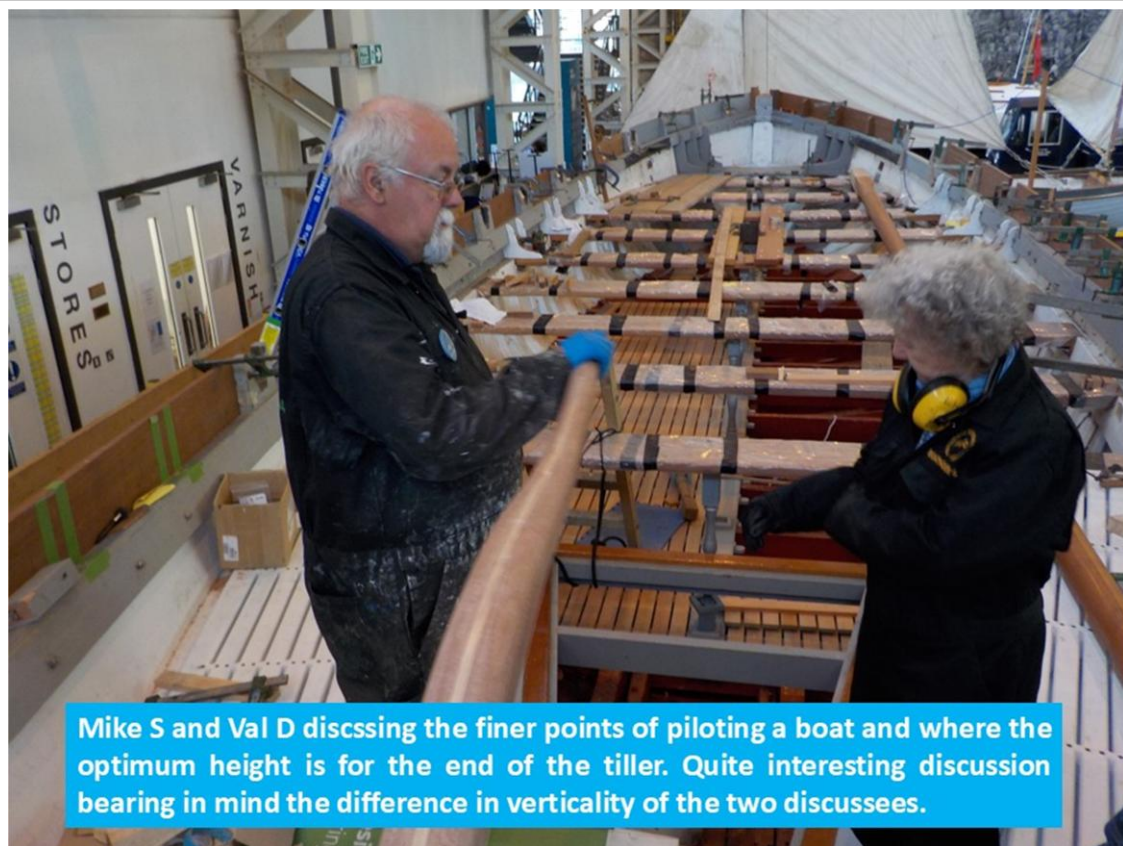
Mike S and Val D discussing the finer points of piloting a boat and where the optimum height is for the end of the tiller. Quite interesting discussion bearing in mind the difference in verticality of the two discussers.

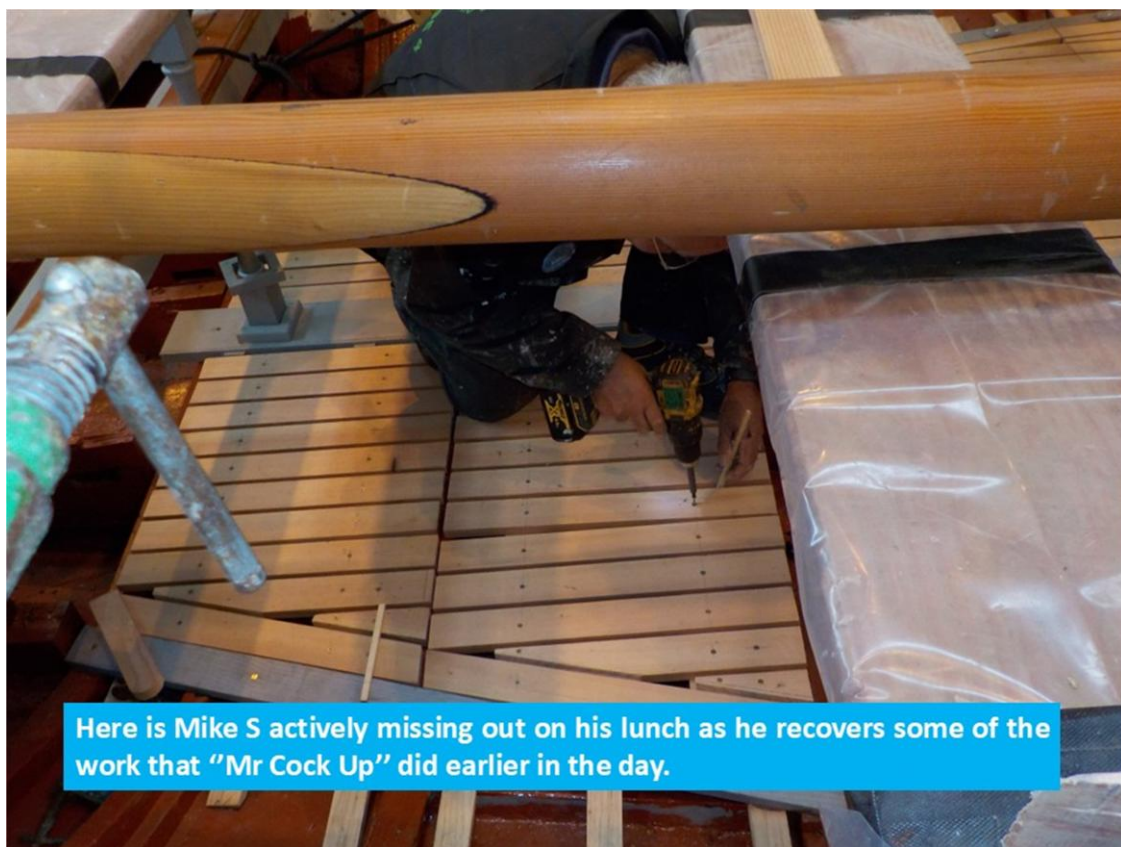
Here is Mike S actively missing out on his lunch as he recovers some of the work that "Mr Cock Up" did earlier in the day.

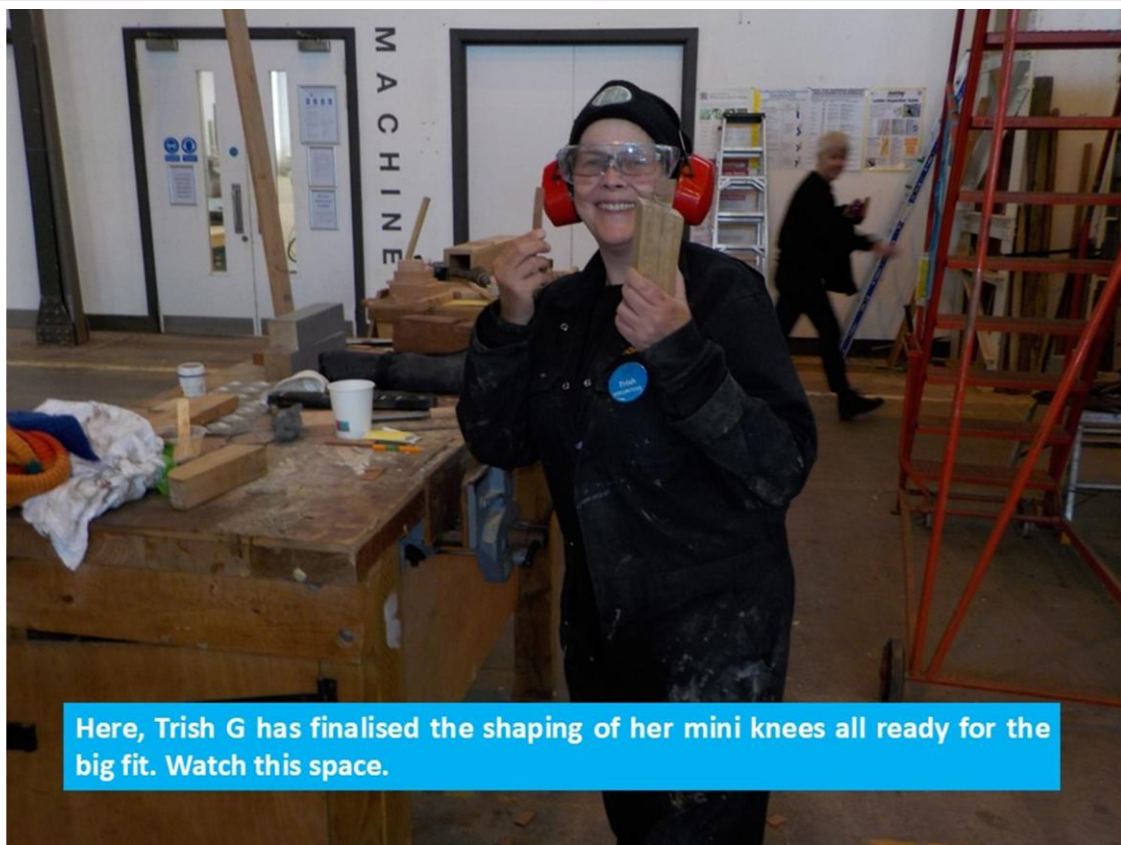
Here, Trish G has finalised the shaping of her mini knees all ready for the big fit. Watch this space.

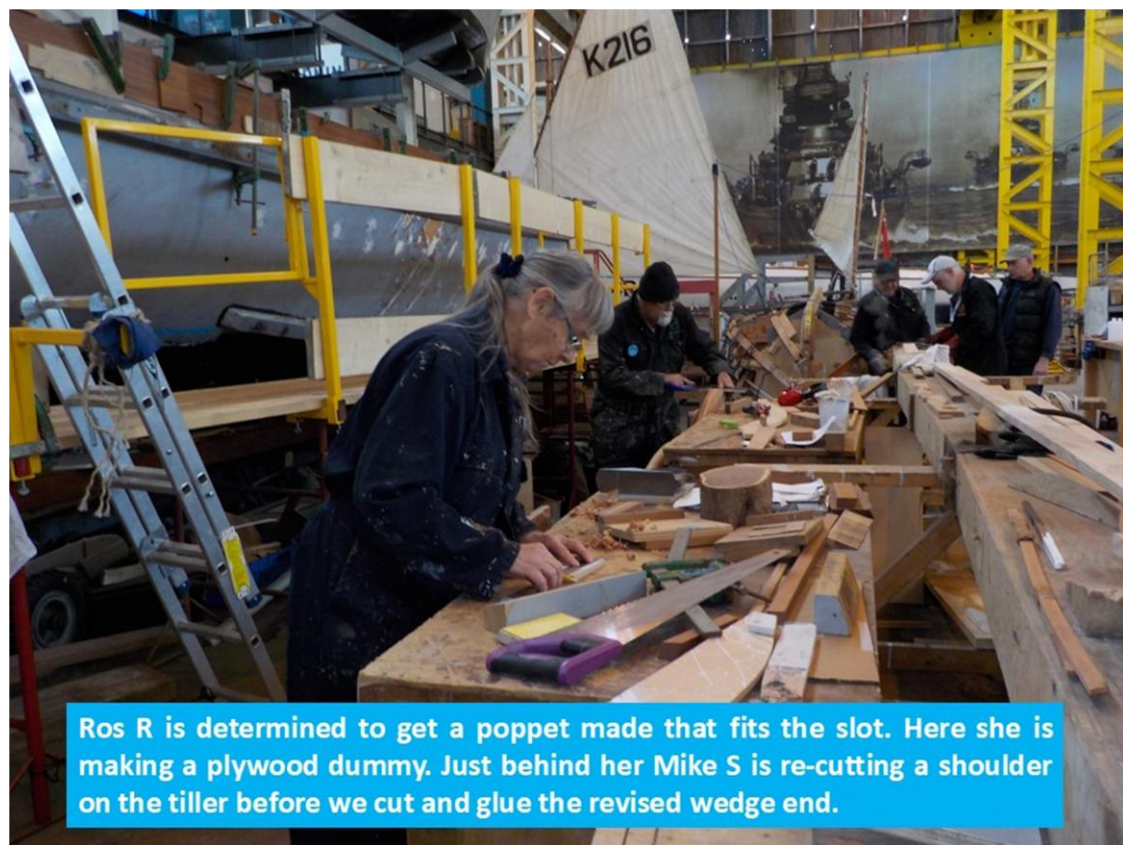
Ros R is determined to get a poppet made that fits the slot. Here she is making a plywood dummy. Just behind her Mike S is re-cutting a shoulder on the tiller before we cut and glue the revised wedge end.

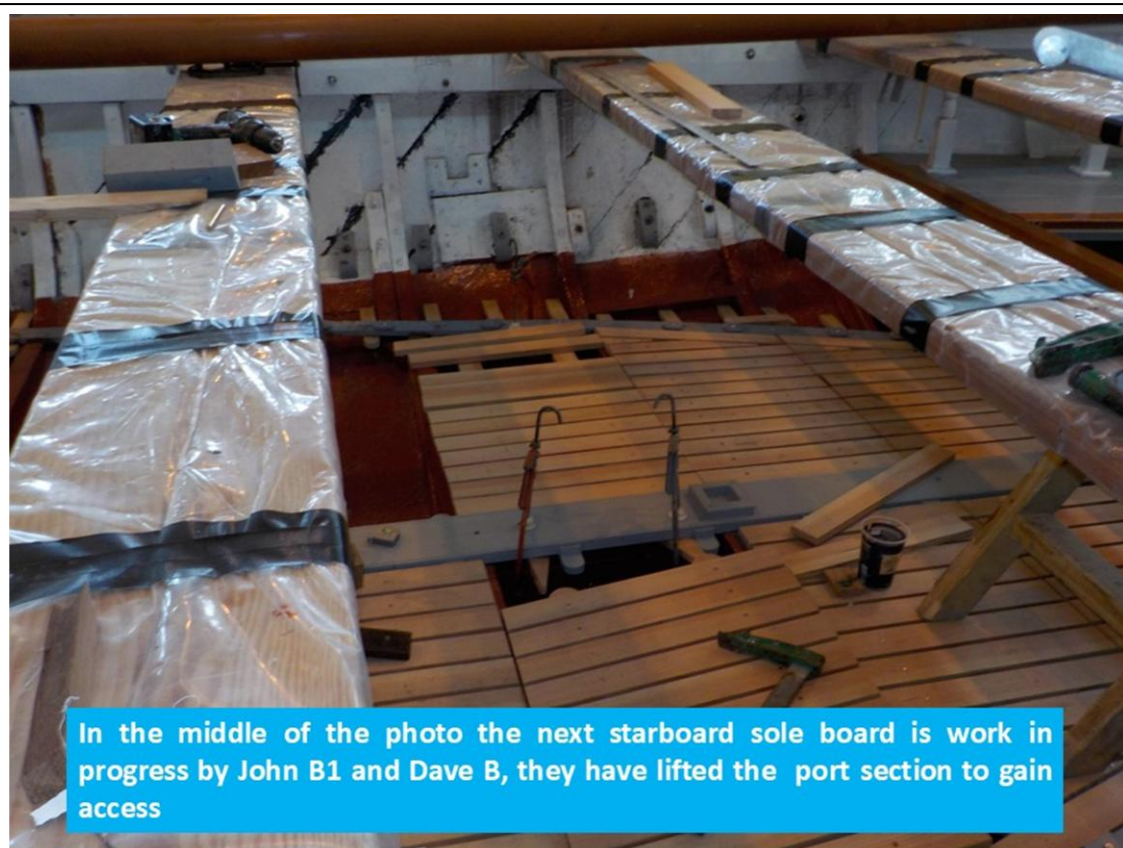
In the middle of the photo the next starboard sole board is work in progress by John B1 and Dave B, they have lifted the port section to gain access

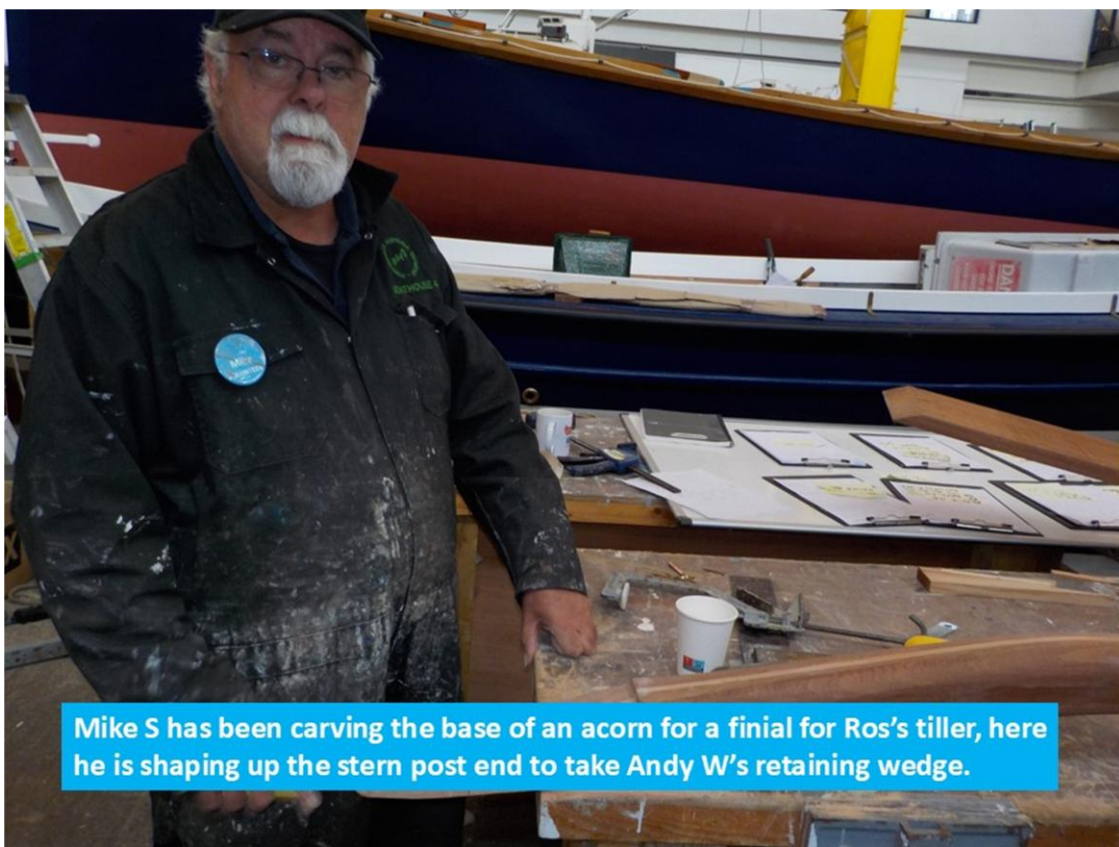
Mike S has been carving the base of an acorn for a finial for Ros's tiller, here he is shaping up the stern post end to take Andy W's retaining wedge.

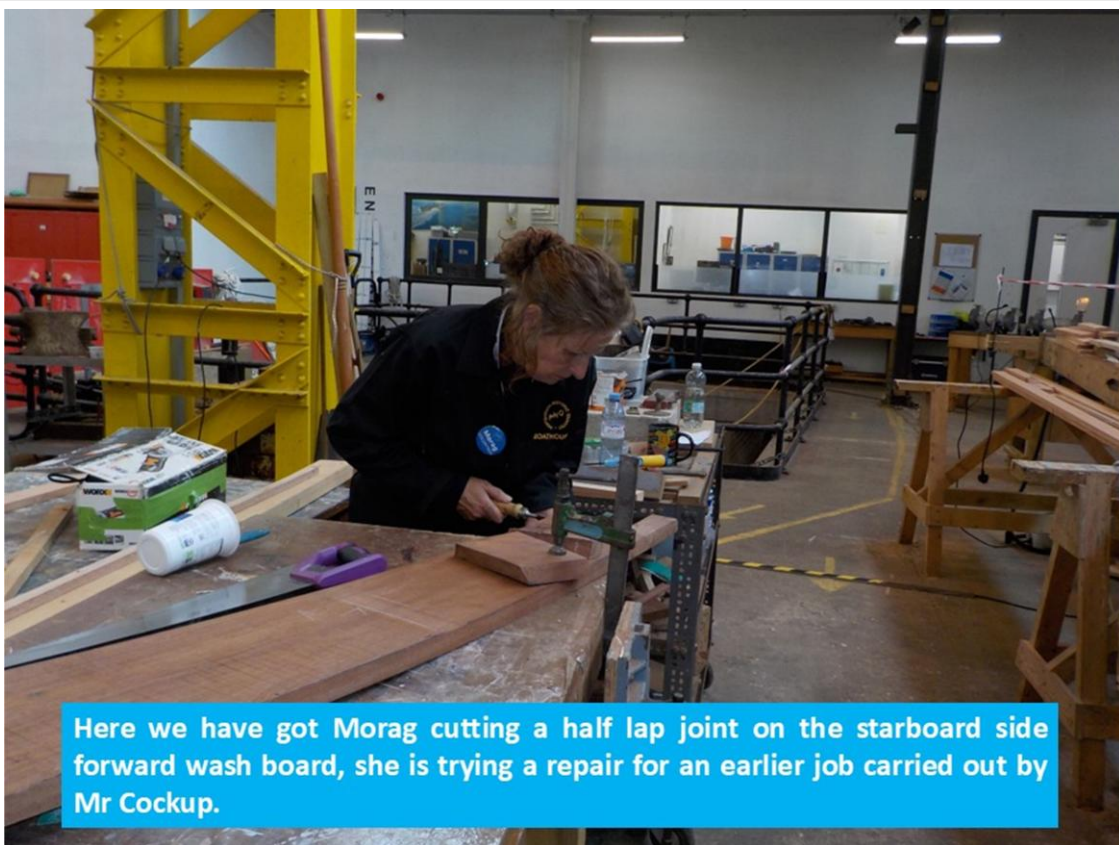
Here we have got Morag cutting a half lap joint on the starboard side forward wash board, she is trying a repair for an earlier job carried out by Mr Cockup.

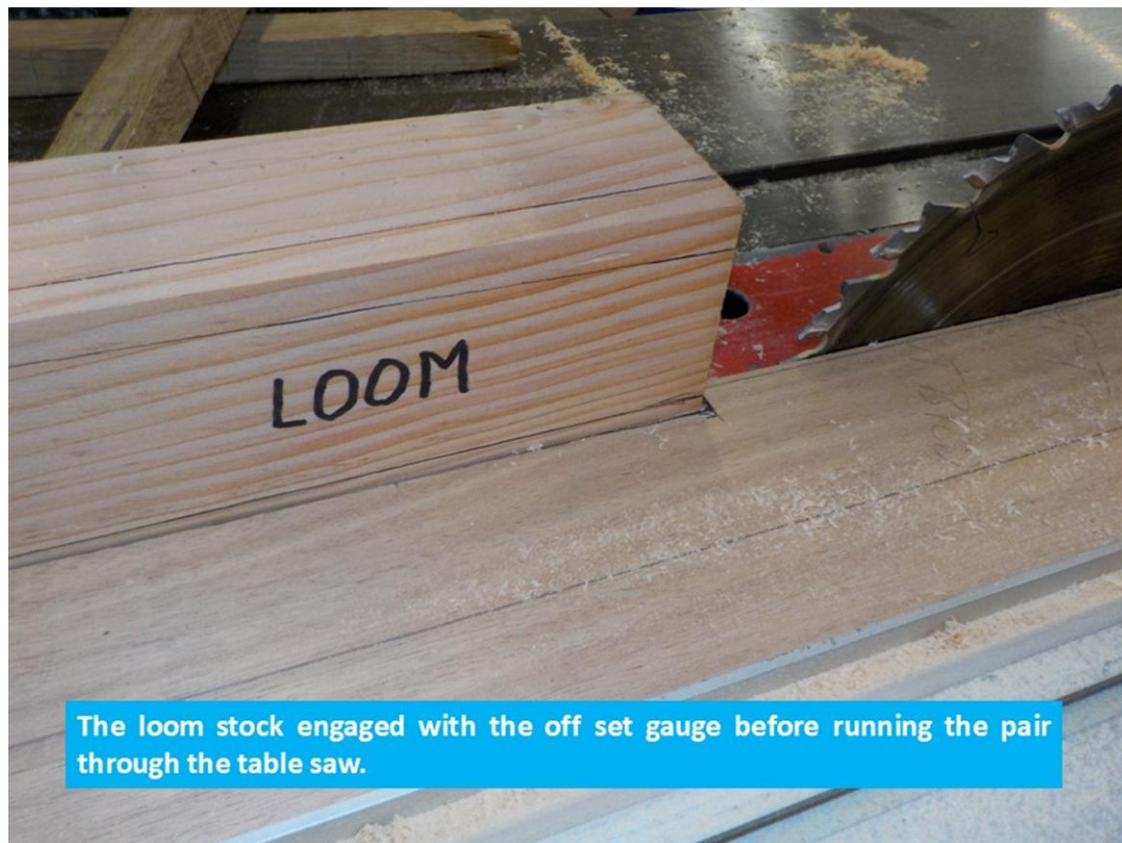
The loom stock engaged with the off set gauge before running the pair through the table saw.

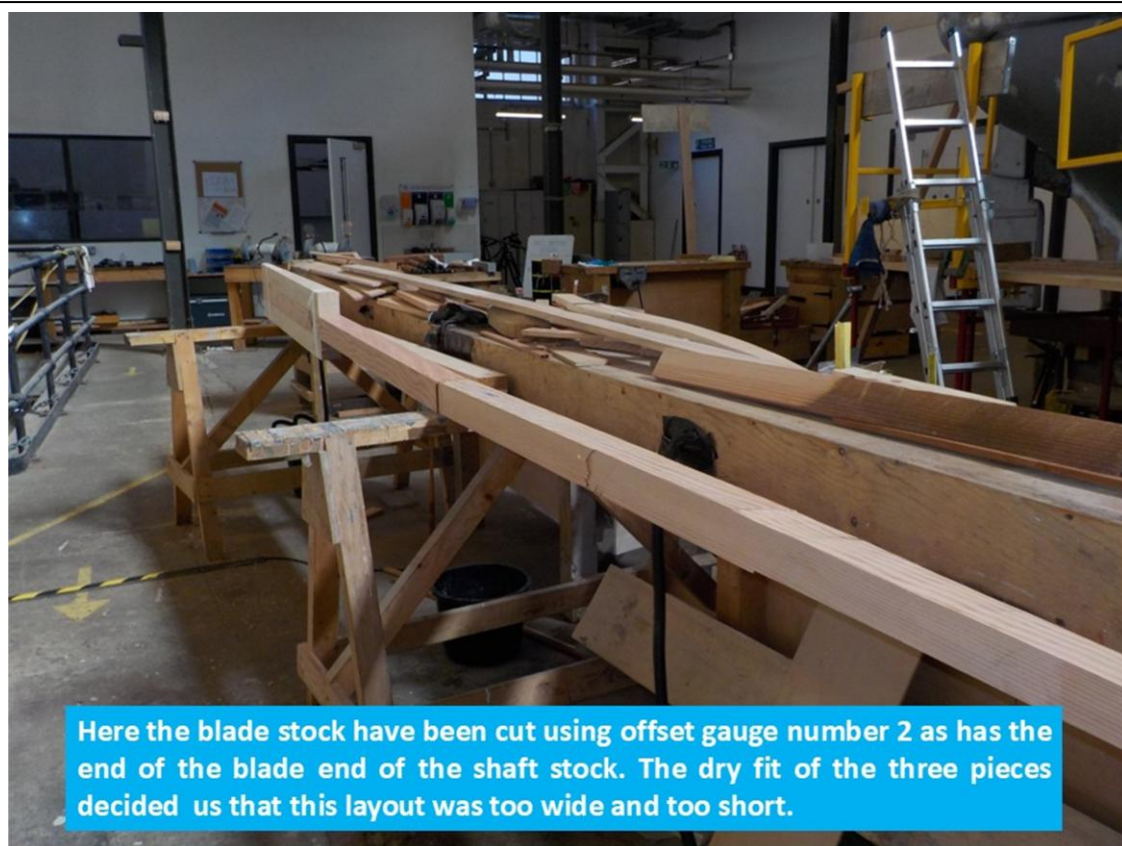
Here the blade stock have been cut using offset gauge number 2 as has the end of the blade end of the shaft stock. The dry fit of the three pieces decided us that this layout was too wide and too short.
